PHASE I ENVIRONMENTAL SITE ASSESSMENT

WATER TANK PROPERTY, CITY OF ST. PAUL ST. PAUL ISLAND, ALASKA

August 20, 2003

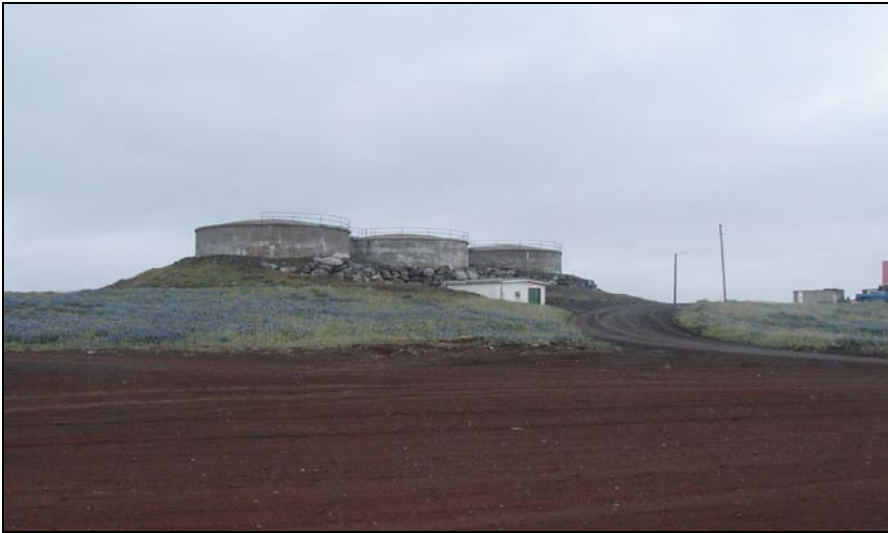
Photograph 1

View of water tank property looking from City Hall to the northwest.

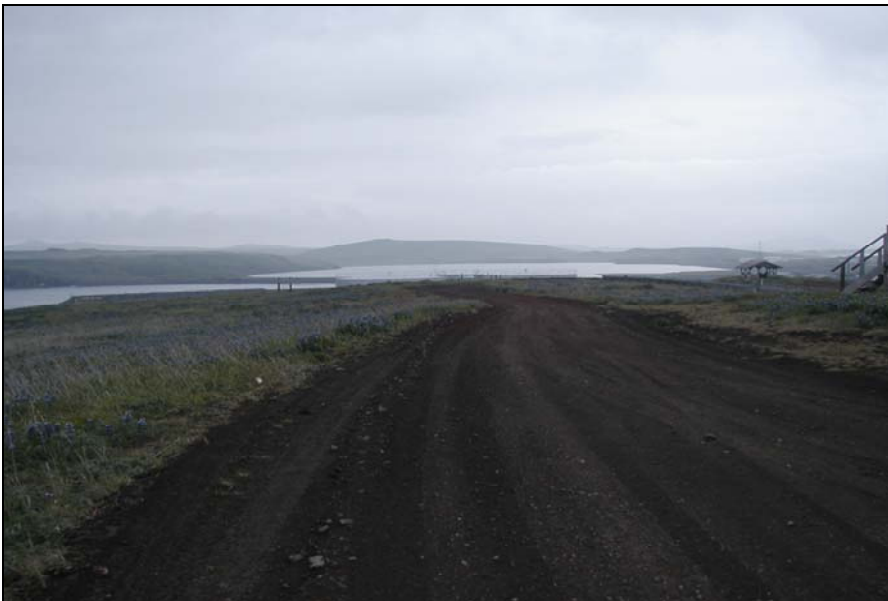
Photograph 2

View to the north from water tank property; the top of the two large harbor fuel tanks are visible at end of the road.

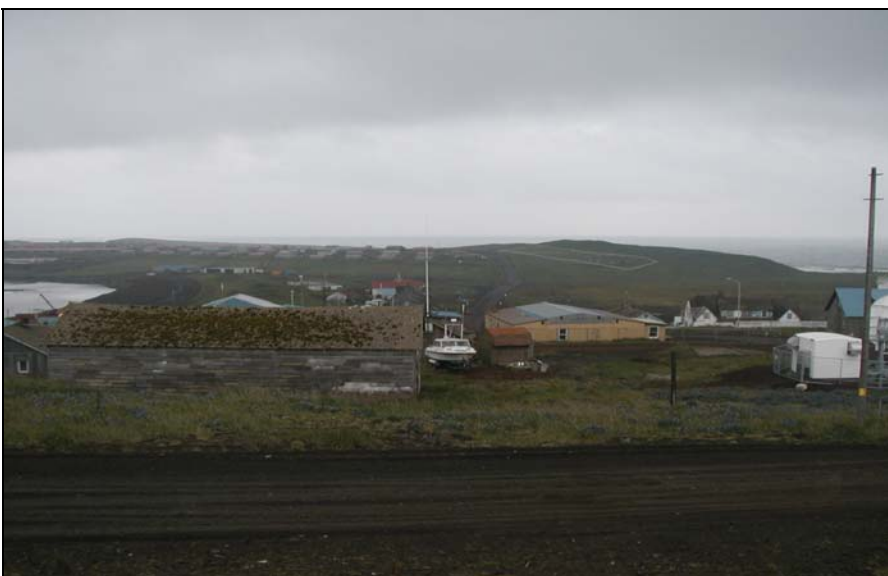
Photograph 3

View to the east from water tank property.

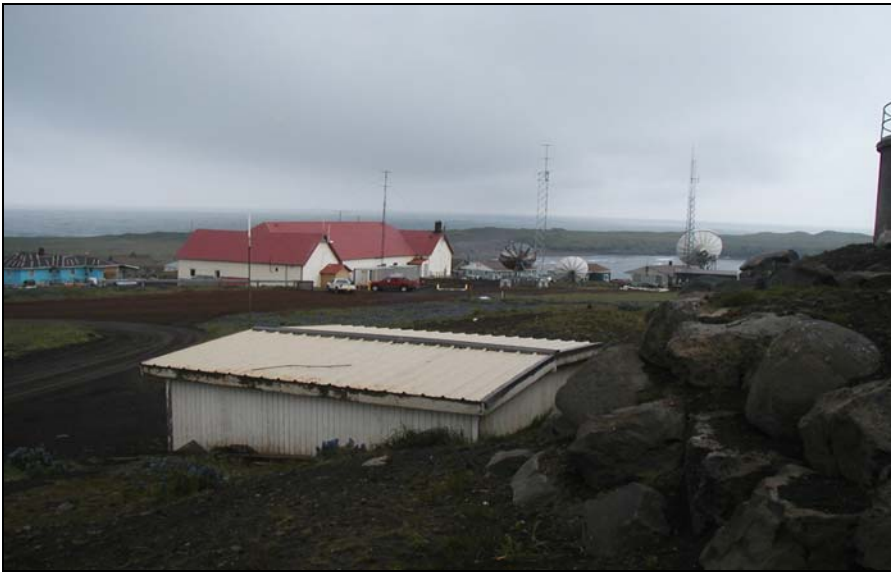
Photograph 4

View to the south from water tank property; City Hall and satellite dish locations are visible.

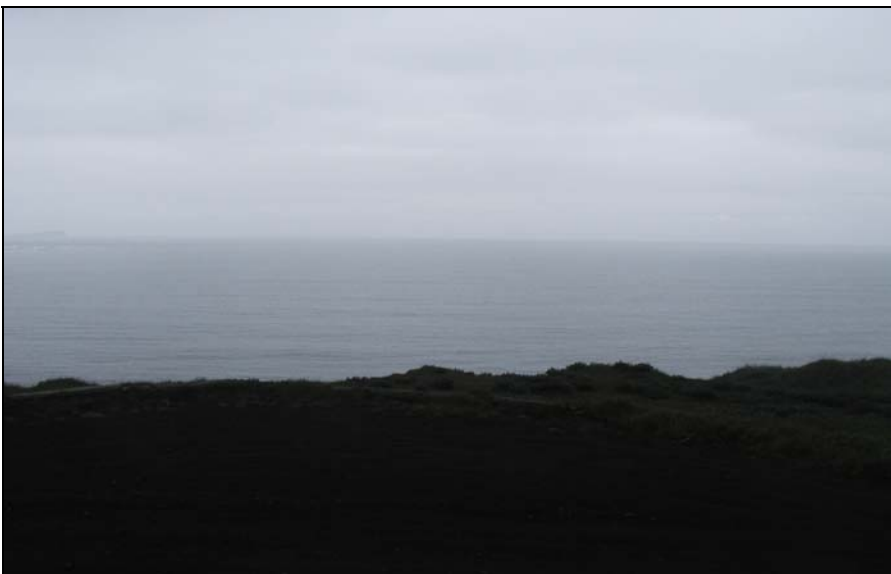
Photograph 5

View to the west from water tank property; Bering Sea visible.

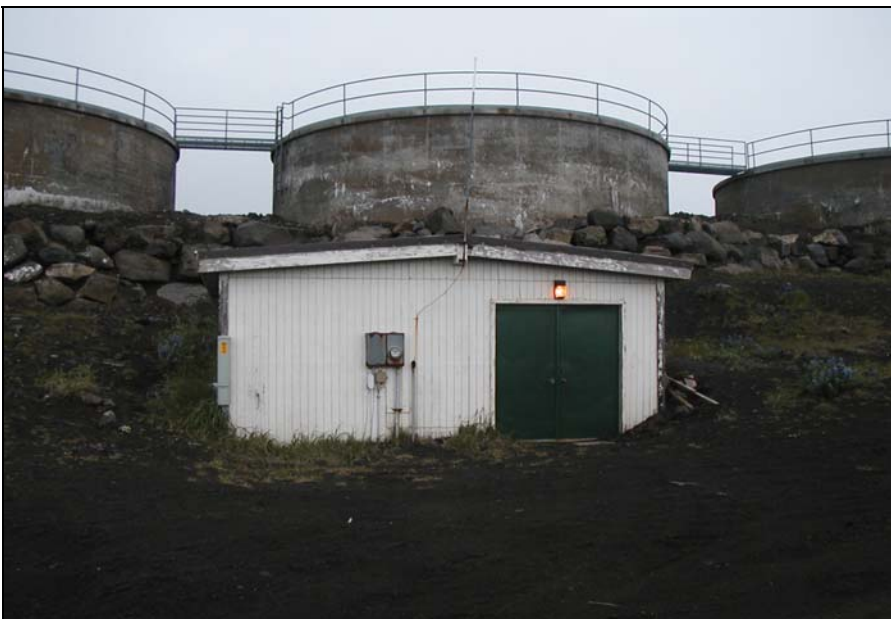
Photograph 6

Observations: The pumping house located adjacent to the east side of the water storage tanks was found to be devoid of any containers of chemicals or containers of unknown use or origin.

Observations: No evidence of discharges were observed inside the pumping house to the east of the water storage tanks.

View of pumping house on east side of water storage tanks.

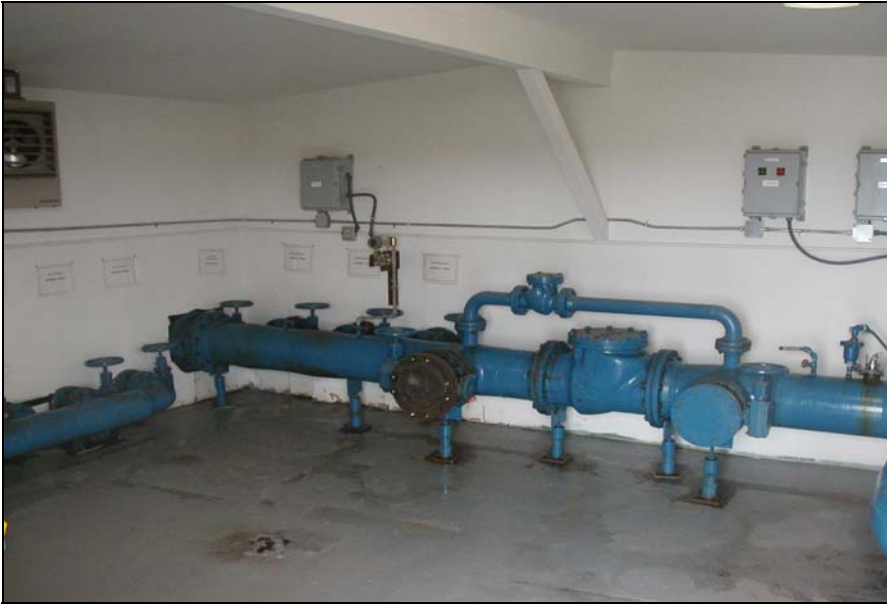
Photograph 7

View of the interior of the pumping house.

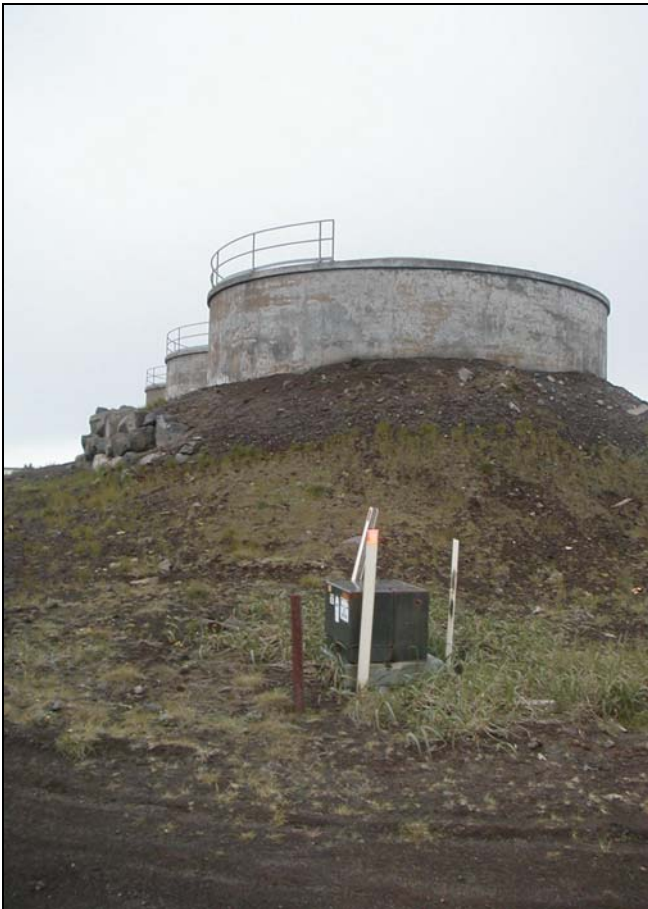
Photograph 8

Observations: One small transformer (estimated 50 KVA) was identified near the northern edge of the subject property; however, interviews with city officials indicate that this transformer does not contain PCBs. In addition, city officials had no recollection of PCBs ever being used on the subject property. No equipment suspected to contain PCBs was identified at the subject property during the site reconnaissance.

View of the electrical transformer at north end of water tank property.
